SUBJECT: Animal Feeding Operation (AFO) Compliance Inspection for –Neal Brenneman, County –
Sioux, – Facility #56310

IOWA DEPARTMENT OF NATURAL RESOURCES AFO INSPECTION REPORT

FACILITY LOCATION	Facility: Neal Brenneman			Facility ID#: 56310	
	Address: 2130 380th Street	City: Sioux Center	State: IA	Zip: 51250	
	PLSS: Section 26, Garfield Township (T96N, R47W), Sioux County				
OWNER	Name: Neal Brenneman				
ANIMAL HOUSING TYPE	<input type="checkbox"/> Confinement <input checked="" type="checkbox"/> Open Lot <input type="checkbox"/> Combined (Confinement & Open Lot)				
ANIMAL INFORMATION	Animal Type(s)	Capacity	Current Head	Number of Bldgs./Pens	
	Beef Cattle	999	700	4 pens	
	Date of Construction: unknown		Date of Expansion: 2010

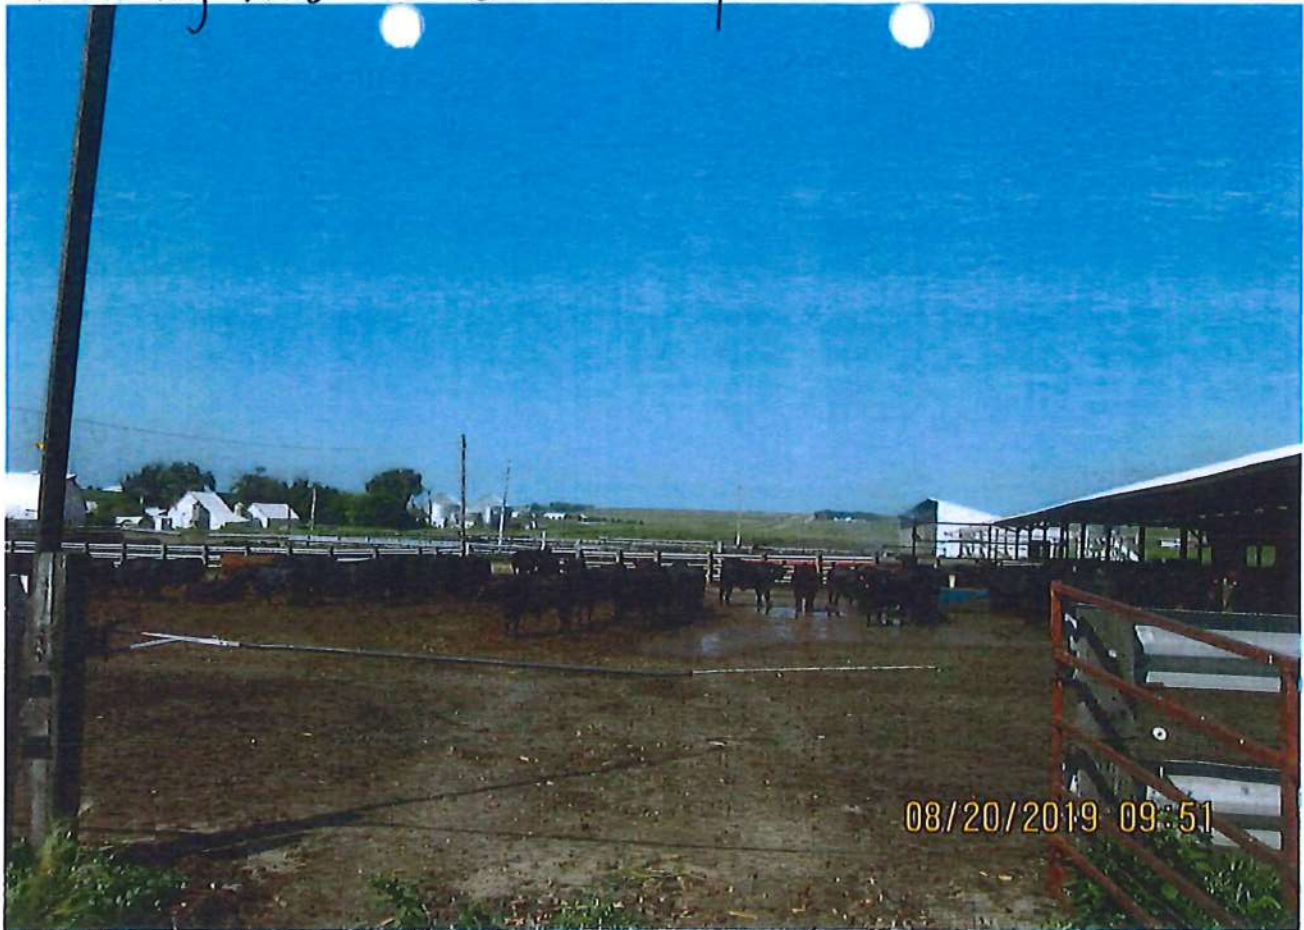
There was no evidence of runoff entering Dry Creek and your structures appeared to be functioning as designed. Overall, your pens were in great condition and runoff is not an issue.

Looking West at the east pens.

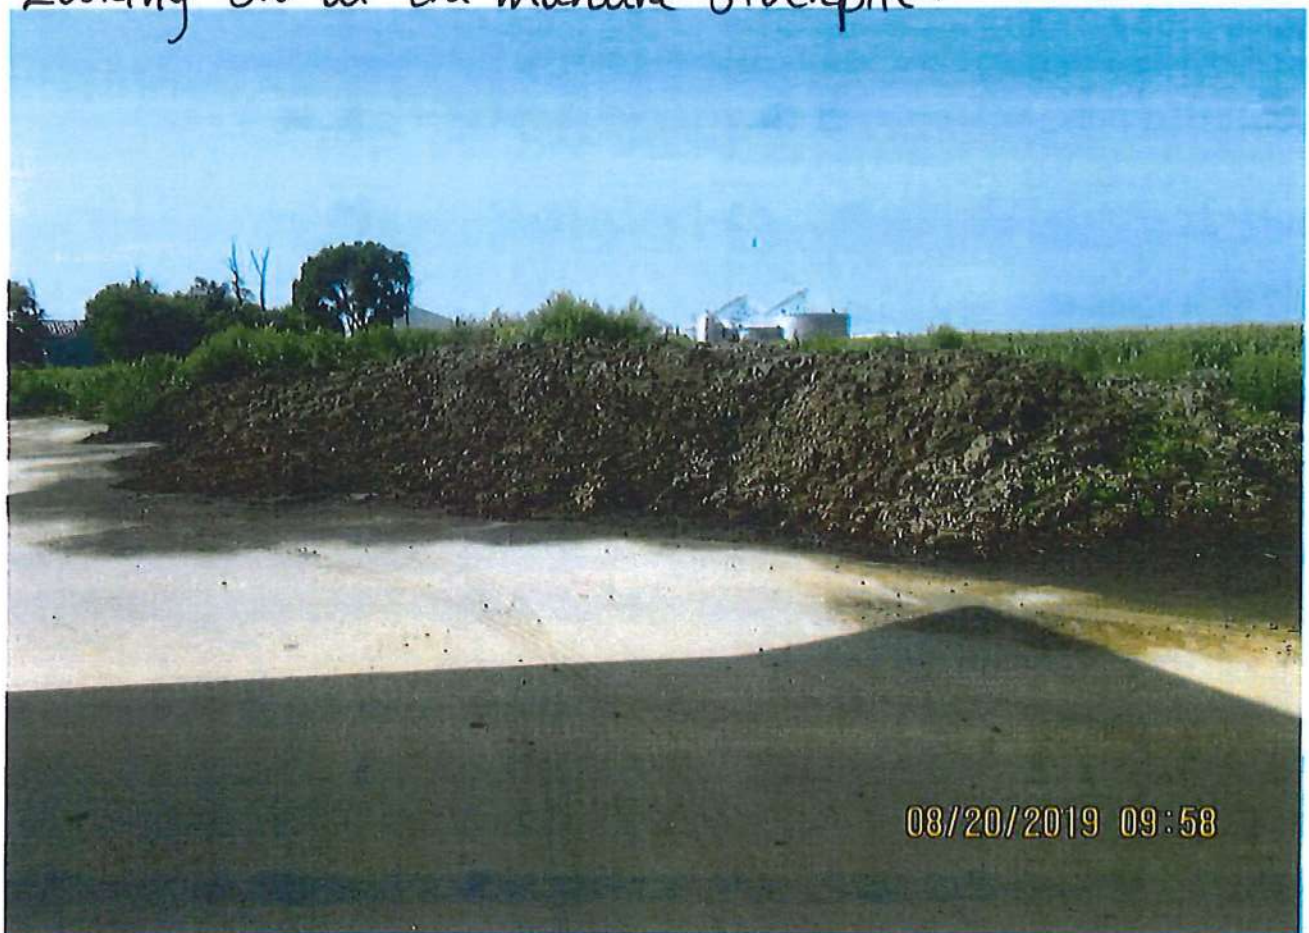
Manure is stockpiled to the west of the west pens and is land applied in the fall.

Looking SW at the manure stockpile.

- Land apply manure at agronomic rates.
- Settle out solid manure prior to discharging to any water of the state and you cannot cause a water quality violation.

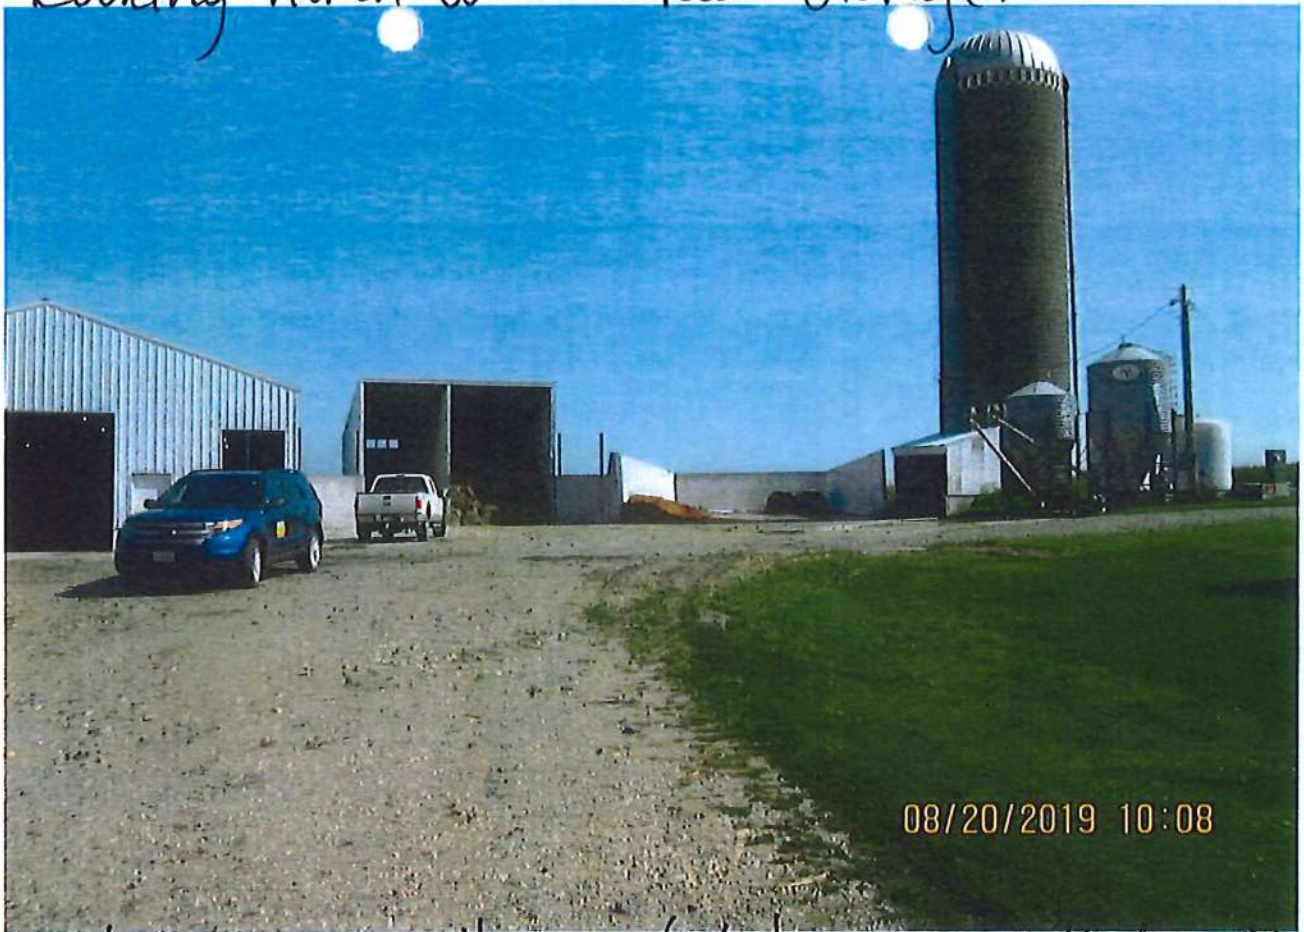
Your feed storage area is located to the northeast of your east pens. All feed is covered and runoff is not a concern.

Looking north at the feed storage.
